# **OPERATING EXPERIENCE WEEKLY SUMMARY**

**Office of Nuclear and Facility Safety**

**July 17 - July 23, 1998**

**Summary 98-29**

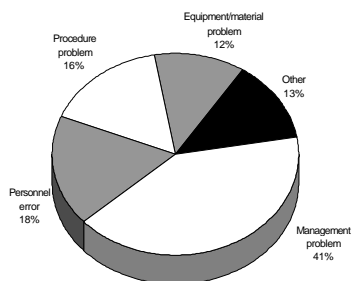
OEAF engineers searched the ORPS database for events with all narrative of sealed sources from January 1990 to present and found 89 occurrences. Figure 5-1 shows the distribution of root causes for these events. A review of these occurrences shows that managers reported 41 percent of the root causes as management problems, 18 percent as personnel errors, and 16 percent as procedure problems. Further review of the management problems shows that 49 percent were reported as inadequate administrative control, and 38 percent were reported as policy not adequately defined, disseminated, or enforced. Further review of the personnel errors shows that 43 percent were reported as inattention to detail. Further review of the procedure problems shows that 64 percent were reported as defective or inadequate procedure.

**Figure 5-1. Root Causes for Sealed Source Occurrences<sup>1</sup>**

<sup>1</sup> OEAF engineers searched the ORPS database using the graphical users interface for reports that contained all narrative of "sealed source" from January 1990 to present and found 89 occurrences. Based on a random sampling of 20 events, OEAF engineers determined that each slice is accurate within  $\pm 1.0$  percent.
